Street lighting update. 21/01/2022

Replacement lights for reconnection.

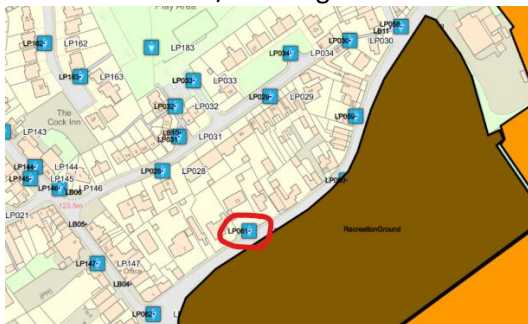
1. WSL 19.3 LP061 o/s 13 Leighton Road

UKPN confirmed on 3rd November that the supply had been installed.

CU Phosco were informed that the supply had been installed and requested to attend to complete the reconnection and testing of the lantern. Following an inspection, it was confirmed that the light was still out. Enquiries with CUPhosco determined that there was no supply to the column when they reconnected the lantern.

The absence of a supply was immediately reported to UKPN on 8th December 2021. There has been no response to date. A follow up on this situation has been issued to UKPN operatives including higher management to whom the complaint will be submitted, when prepared. (See below*)

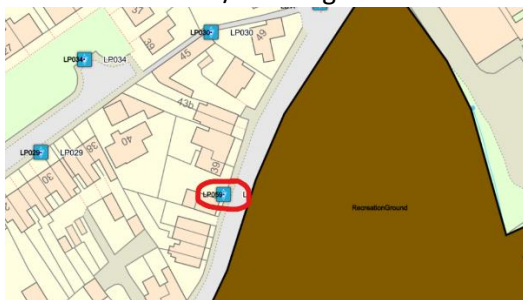
2. WSL 20.1 LP 059 o/s 39 Leighton Road

See * Below.

*There has been no significant progress with these three outstanding light reconnections. A formal complaint about the service received from UKPN is in course of preparation. We are continuing to press UKPN for replies and particularly to reinstate the services to 2,3 and 4 above.

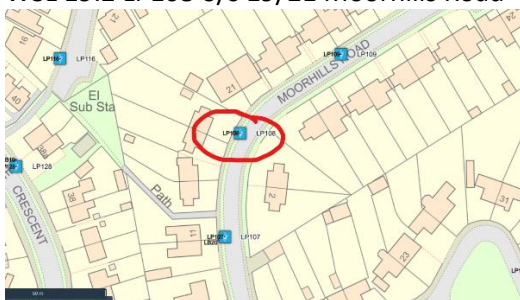
3. WSL 19.2 LP108 o/s 19/21 Moorhills Road

See * Below.

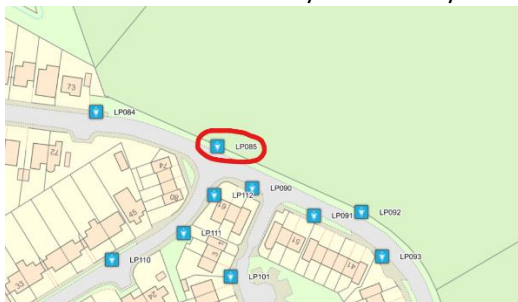
4. WSL 19.4 LP085Moorhills/Moorlands/ Moorlands Road junction.

See * Below

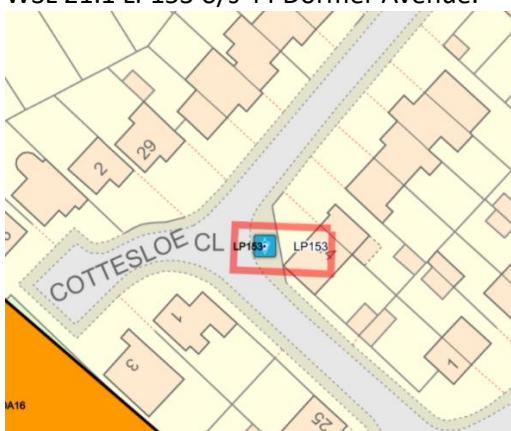
5. WSL 21.1 LP153 o/s 44 Dormer Avenue.

The alternative Independent Connection Providers (ICPs) approached for quotes to reconnect the above streetlights were requested to provide quotes for the transfer of service.

One quote has been received from an alternative ICP.

For the Council to engage the services of the alternative ICP to arrange the reconnections an Asset Owners Agreement needs to be in place with UKPN. This is in progress with a different department of UKPN. If such an agreement is confirmed the Council will be in a position to employ an alternative ICP for supply connections to the streetlights.

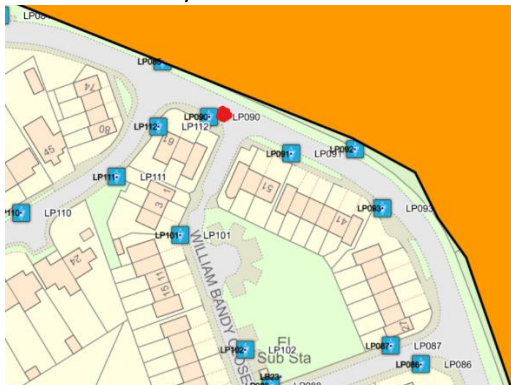
1. SF21.3 LP090 o/s 57 Moorlands Road.

This was attended by a contractor and found to have a dead supply and damaged door. The door has been fixed back and cable tied but the dead supply needs to be attended by UKPN. This has been reported to UKPN. The need for a more permanent repair to the door is being investigated.

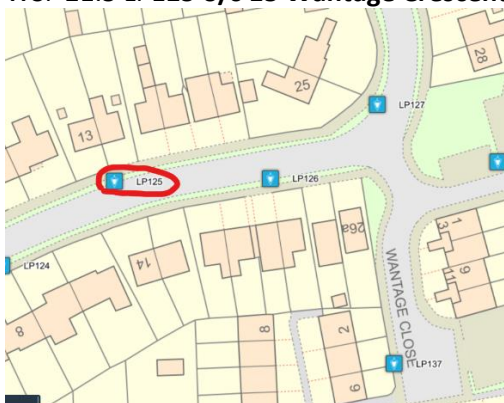
2. WSF 21.5 LP125 o/s 15 Wantage Crescent.

This is believed to possibly have been disconnected in error by Sparkx who were requested to carry out an emergency disconnection of the flashing lamp outside **16 Wantage Close**. Sparkx have been requested to confirm that they have reconnected the light they disconnected in error. It has not been reported as a fault for repair at this stage.

An inspection is being carried out to establish whether this has been completed.

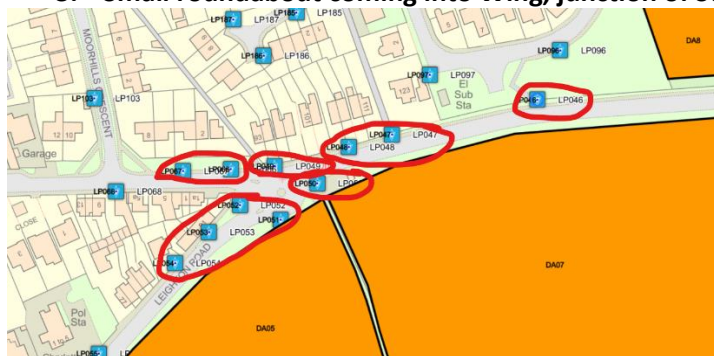
3. Small roundabout coming into Wing, junction of Stewkley.

Latest report from Buckinghamshire Council 19/11/21

Thank you for your report. We are currently building a package of works where your report will be addressed when we are next in the area.

No further update has been received.

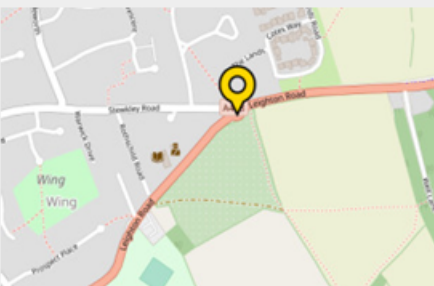
A418 Roundabout with Stewkley Road and Stewkley Road

We have received reports that the streetlights in this area are still inoperative despite several previous reports and assurances that they would be given urgent attention. Please attend and repair all the defective lights without further delay.
